Low Cost Residential Sprinkler Tests

These tests were carried out on Tuesday 4th July at a property due for demolition in the Huddersfield area of Kirklees in West Yorkshire.

The aim of the test was to see how a low cost sprinkler installation dealt with a demonstration “front room fire”

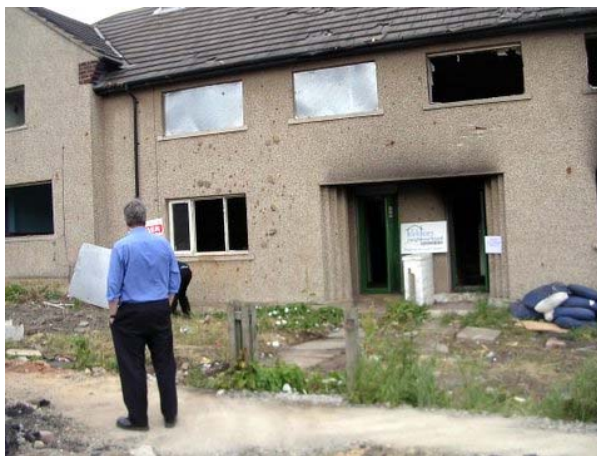
Fig 1 External view of the house used in the test

The house to be used was a brick built 3-bedroom semi-detached council house that was due for demolition. The only services left connected to the property was the water supply and from this a supply pipe was to be run from the kitchen, up to first floor level, along the floor and then dropping two sprinkler heads in to the lounge below.

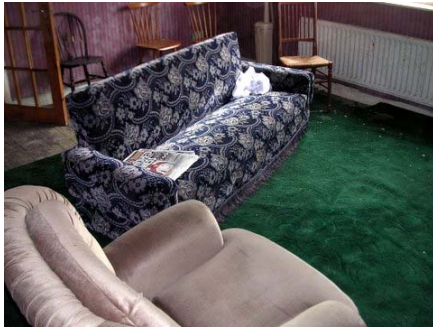
Fig 2 Internal view of the lounge set up

The lounge was the only room in the building fitted with sprinklers, furniture was minimal being an armchair and settee with cushions, a small portable TV on a wooden table, some wooden dining room chairs and a draw unit. The room was fitted with carpet. Additional sundry items were used to enhance fire loading as both the chair and settee met current furnishing safety regulations, these were newspaper, some video cassettes and an upright vacuum cleaner.

The first test placed the settee in the centre of the room approximately mid way between the two sprinkler heads some newspaper and cushions were placed on the settee (As in fig 2). The door to the kitchen was closed, the door to the hall was left open

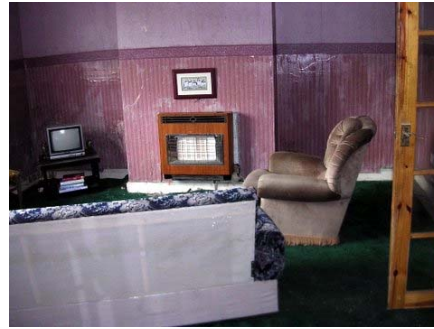
Fig 3 Internal view of the lounge set up

The same furniture was used for this test as in test 1. The item ignited was a small portable TV placed on a wooden table in the left hand chimney alcove (see fig 3). The door to the kitchen and lounge were closed and to reduce the heat loss boarding was placed across the open window to cover 2/3 of the opening from the top. A full crisp packet placed next to the TV was used as an ignition source.

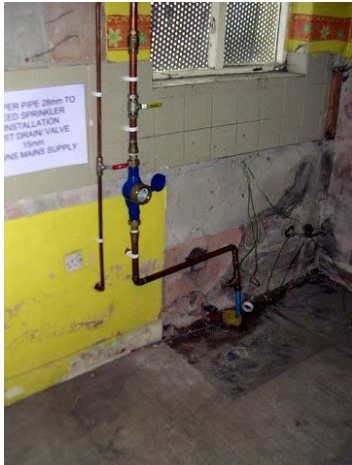
From the supply inlet in to the property 28mm copper pipe was connected to a flow meter and then laid up the wall, through the ceiling, along a bedroom floor, through a wall and across another bedroom floor. Dropped pipework was then used to position two sprinkler heads in the lounge below.

Fig 4 Supply inlet and flow meter

An inlet main pressure to the house could not be measured but indicated supply pressure from a hydrant via 70mm hose to a fire appliance pump in the road outside was indicated at 3.5bar. Flow rate was measured at 42 litres a minute through two heads.

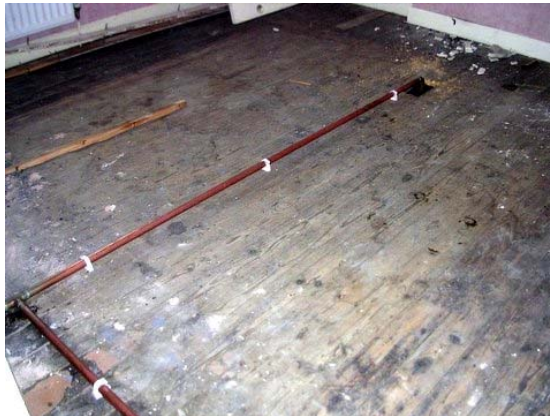
Fig 5 The pipe installation above the lounge

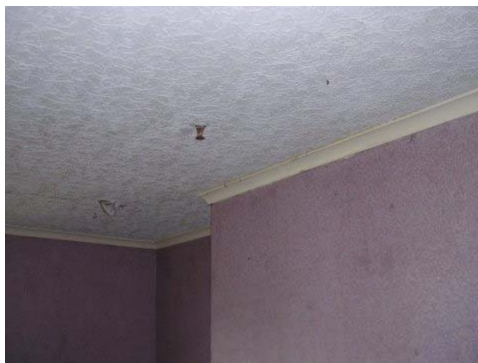
Pendant sprinkler heads were used with red bulbs designed to activate at 68°C (unfortunately these were not residential sprinkler heads).

Fig 6 One of the sprinkler heads this one is in front of the chimneybreast

Critically the position of the chair in the alcove appears to have placed most of the chair in an area where the discharge from the sprinkler head could not penetrate due to the chimneybreast acting as a shield. Spacing the head further from the chimneybreast could have overcome this problem.

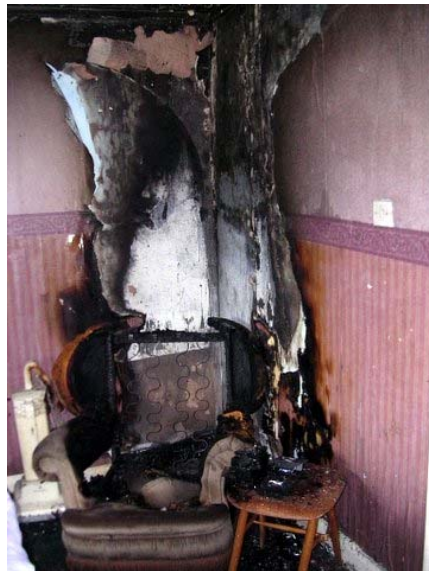
However it was noted that damage to the ceiling and other contents of the room was minimal and it is thought that the sprinklers did make a significant contribution in this area

Fig 7 Test 2 after fire, chimneybreast s to the left

The smoke detector in the hall sounded after 20 seconds. The chair continued to burn with small flame for some time until the combustion modified foam and timber frame became involved. The sprinkler nearest the chimneybreast activated after 12minutes. 23 seconds the second head activated shortly after.

After 20 minutes the test was terminated by intervention of a fire crew using a hose reel as the fire was developing and both sprinklers had activated and were not controlling the fire.
